## GM9.5 12 BOLT REGEAR 2014 CHEVY

**Overview:** In 2013 GM has changed the rear-end packages offered in their 1500 series trucks

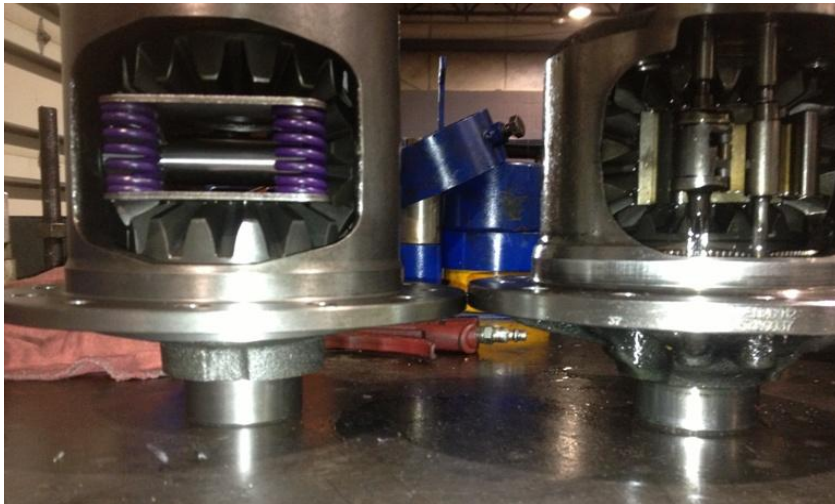
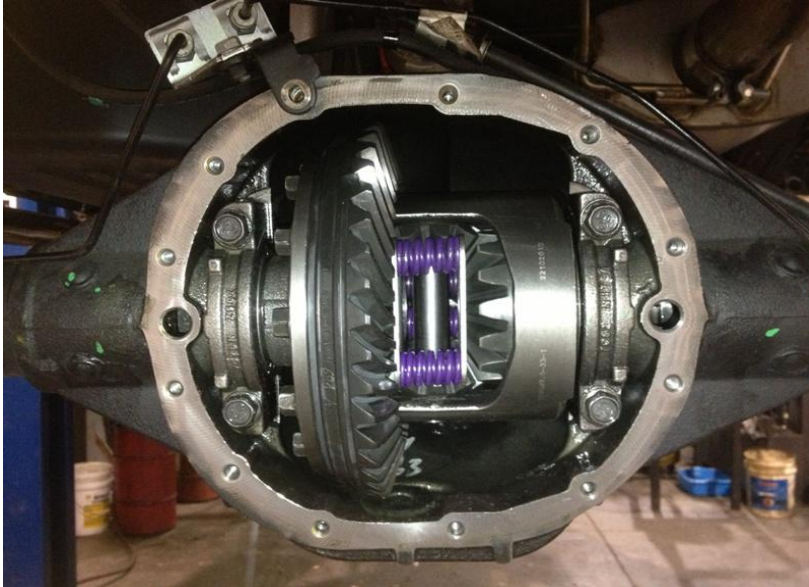
\*\*\*Note Factory Cover does not clear the GM9.5 CASE, we have a Diff cover spacer ring currently (Requires double gasket) and we are producing an aftermarket cover. Heating and bending the cover is possible to achieve clearance BUT VERY TIME CONSUMING, and you must maintain the flat sealing surface. (Recommend Heating cover with a torch and pushing out on it through pinion snout with pinion removed and cover firmly bolted on. Install carrier and check for clearance before moving onto regearing.)
