Whine Noise From Rear of Vehicle

Service Category Drivetrain

Section Axle/Differential

Some 2016 – 2017 model year Tacoma Double Cab 4WD vehicles equipped with a BD22 rear differential may exhibit a whine type noise from the rear of the vehicle. This condition may occur while driving around 50 mph at constant speed, slight acceleration, or slight deceleration and may be caused by rear differential vibration transferring through the chassis and body. Follow the Repair Procedure in this bulletin to address this condition.

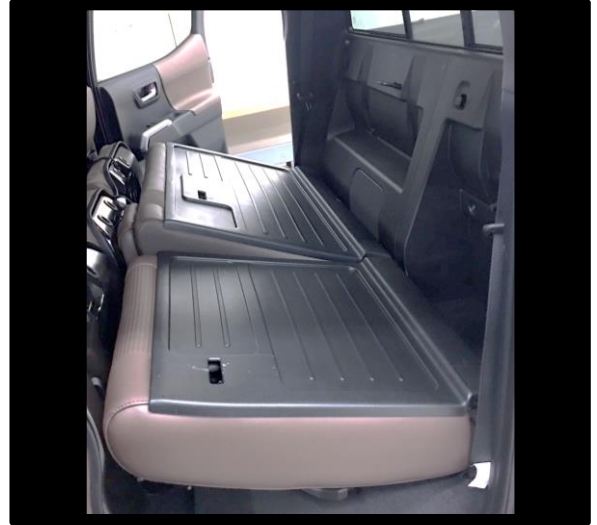
Figure 1.

2. Install the No. 5 pillar pad to the C pillar.
 - A. Fold down the seat and seat back for adequate space during the repair.

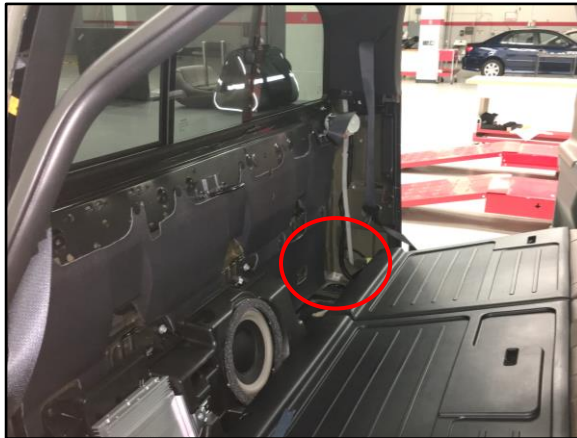
- D. Install the No. 5 pillar pad on the bottom of the C pillar to the RH and LH sides.

Figure 2. Installation Area

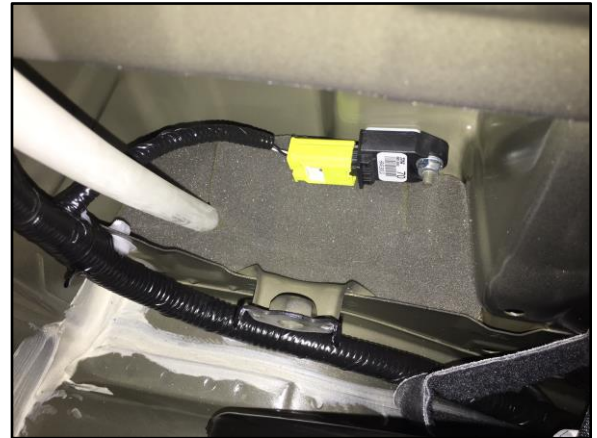
Figure 3. No. 5 Pillar Pad Installed

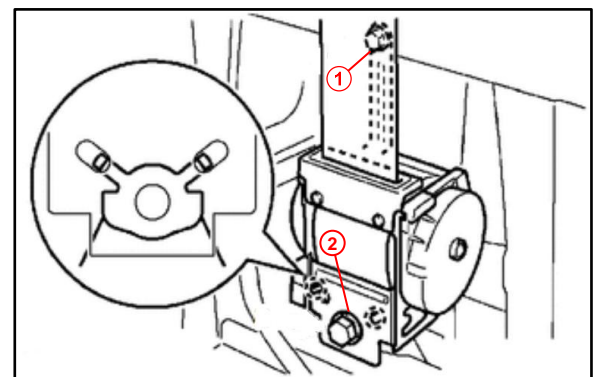
Figure 4.

- F. Torque the seat belt bolts.

Bolt A

Torque: 12.5 N*m (127 kgf*cm, 9 ft*lbf)

Bolt B

Torque: 42 N*m (428 kgf*cm, 31 ft*lbf)

1	Bolt A
2	Bolt B

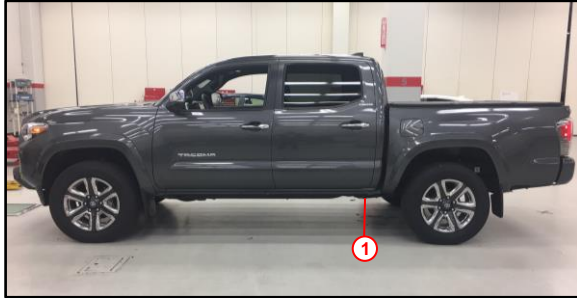
Figure 5.

3. Install the frame dynamic damper.
 - A. Remove and discard the No. 3 nut cab mount (17 mm) and LH and RH cab mounting cushion stopper.

1	No. 3 Cab Mount
----------	------------------------

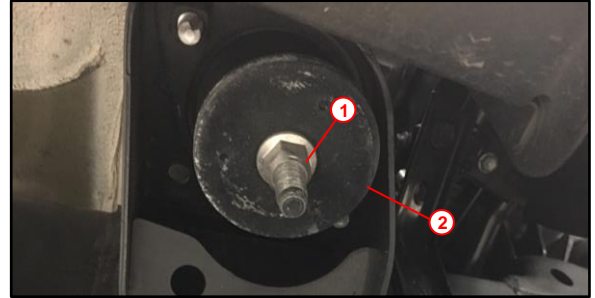
Figure 6.

1	No. 3 Nut Cab Mount
2	Cab Mounting Cushion Stopper

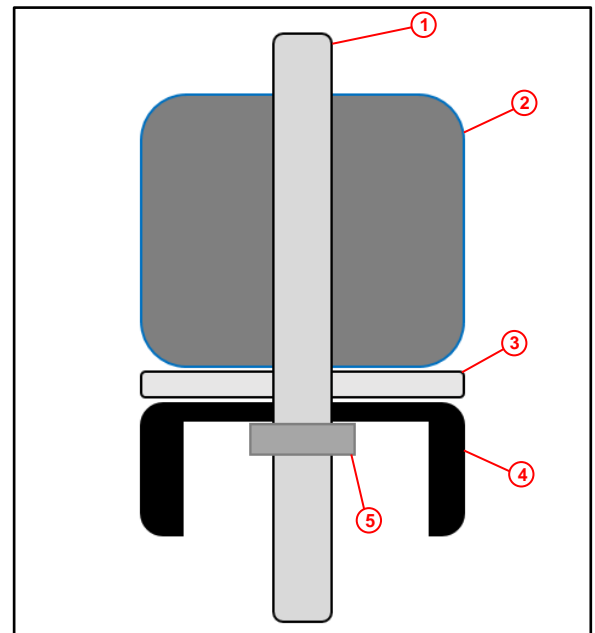
Figure 7.

- B. Install the NEW cab mounting cushion stopper and the NEW frame dynamic damper to the RH and LH cab mount.
 - C. Retighten the cab mount nut.
Torque: 45 N*m (459 kgf*cm, 33 ft*lbf)

1	Body Mounting Bolt
2	No. 3 Cushion Sub-assy Cab Mounting
3	Cab Mounting Cushion Stopper
4	Frame Dynamic Damper
5	Lock Nut
