## TOYOTA 7.5", 8", and 9" BUSHING & TOOL INSTRUCTIONS

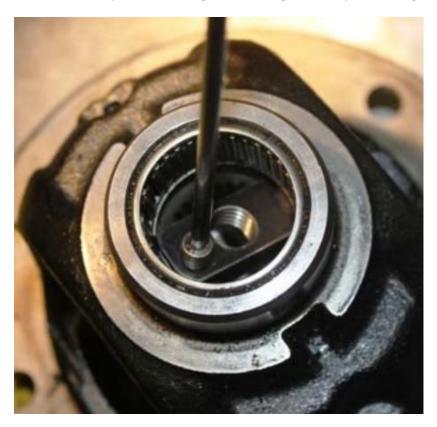
- A. If using ECGS puller tool, stuff a paper towel or some kind of stop in splined area of spider gear this will keep the tool from falling into differential(if this happens you will have to remove the diff separate the case halves and fish it out)
- B. Install machined/threaded insert into the carrier with flat side facing out, use a magnet and install at an angle. It will angle in the gap between the spider gear and needle bearing and then fall into place. If it is angled and wedged take a punch and give it a tap to get it to fall into place.

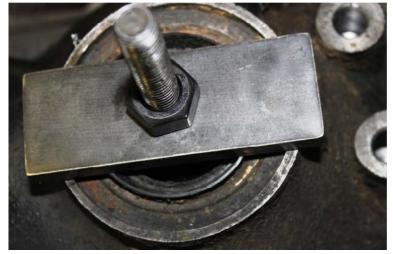
C. Once the Insert is installed thread the puller rod into the insert. Position insert parallel to ground, Pull out on puller rod to hold insert against bearing so that it is centered. (by placing the insert parallel if the tool slips down slightly do to gravity it still should not interfere with inside of carrier)

D. Install plate onto puller rod. Plate will hit the outside round surface of the differential housing. Install the Nut. Maintain pressure against bearing to insure everything stays centered.

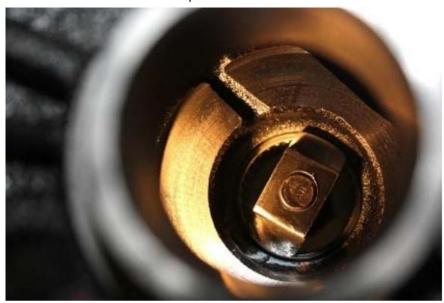
- E. Hand tighten nut to plate, and insure that tool is centered.
- F. Tighten nut against plate and needle bearing will begin to pull out, it should not take a lot of force to remove the bearing. If it feels as though it is not moving, stop and reposition the Insert. It could be hung on the inside of the carrier and if too much force is applied you will bend the insert or damage the tool, once the needle bearing starts to move then you can proceed faster, but be sure initial pull is pulling on bearing. Here is a picture of the insert positioned from the inside to show how critical the position is.

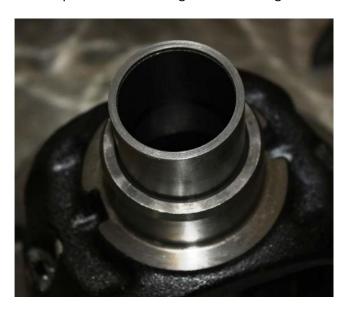
A. With the bearing now removed. Install replacement bushing with steel face out. The steel face protects the bushing while it is being driven in.

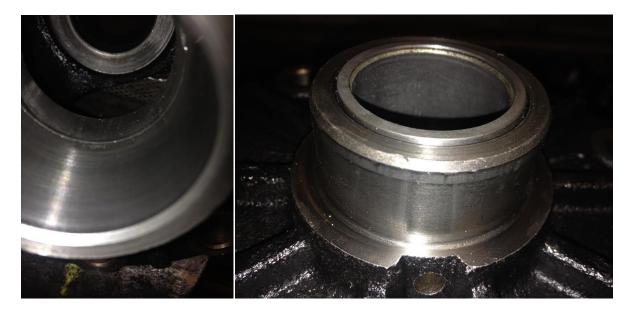
B. Install bushing flush with carrier (Be careful not to drive the bushing past flush as the design of the bushing is longer than the stock needle bearing to provide more support, however if driven to much past flush it will contact the spider gear)

TECH NOTE: The T7.5 bushing is longer than the stock needle bearing. There is room for the bushing to install flush without hitting the spider gear, however some of the Toyota carriers are not bored straight through and there is a ridge on the inside. The ridge will stop the bushing from seating flush. **Installed height is between .030-.065 off of the carrier bore as acceptable**. The bushing can be driven past the ridge of you hit it hard enough but it will damage the bushing and cause the CV shaft not install properly. Drive bushing in to carrier with even firm blows once you feel it stop verify height is between **.030 -.065**
