TOYOTA 7.5" BUSHING & TOOL INSTRUCTIONS

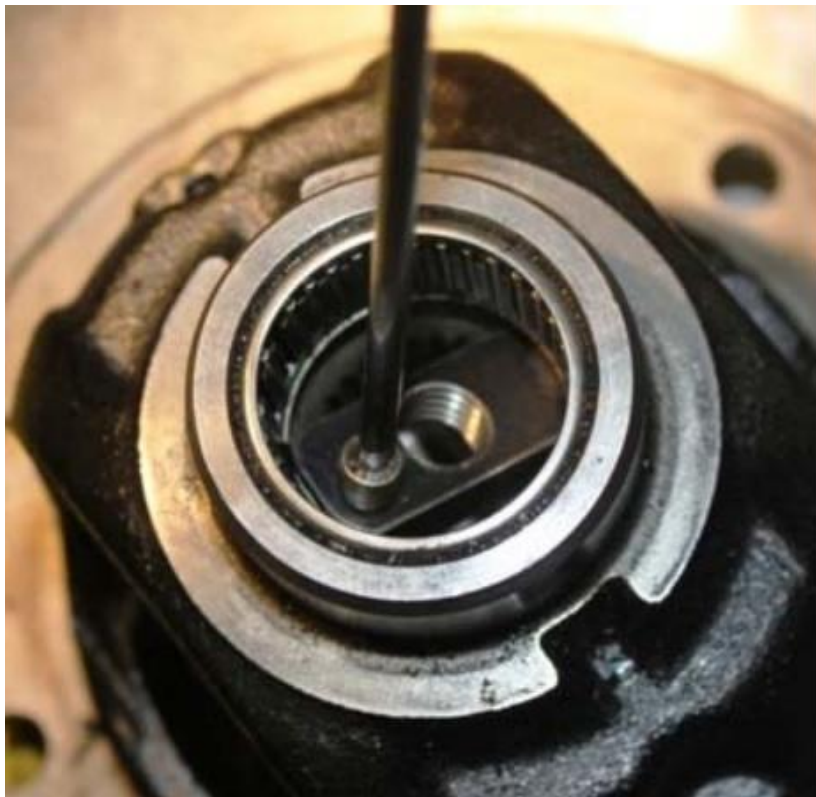
- A. If using ECGS puller tool, stuff a paper towel or some kind of stop in splined area of spider gear this will keep the tool from falling into differential(if this happens you will have to remove the diff separate the case halves and fish it out)
- B. Install machined/threaded insert into the carrier with flat side facing out, use a magnet and install at an angle. It will angle in the gap between the spider gear and needle bearing and then fall into place. If it is angled and wedged take a punch and give it a tap to get it to fall into place.

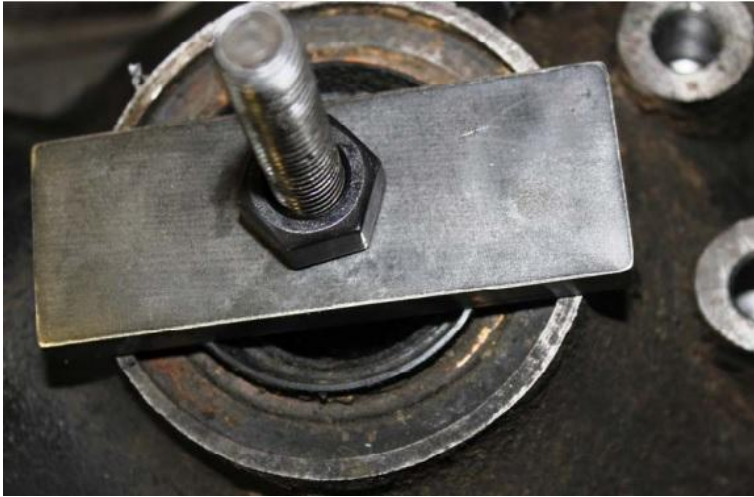
- C. Once the Insert is installed thread the puller rod into the insert. Position insert parallel to ground, Pull out on puller rod to hold insert against bearing so that it is centered. (by placing the insert parallel if the tool slips down slightly do to gravity it still should not interfere with inside of carrier)

- D. Install plate onto puller rod. Plate will hit the outside round surface of the differential housing. Install the Nut. Maintain pressure against bearing to insure everything stays centered.

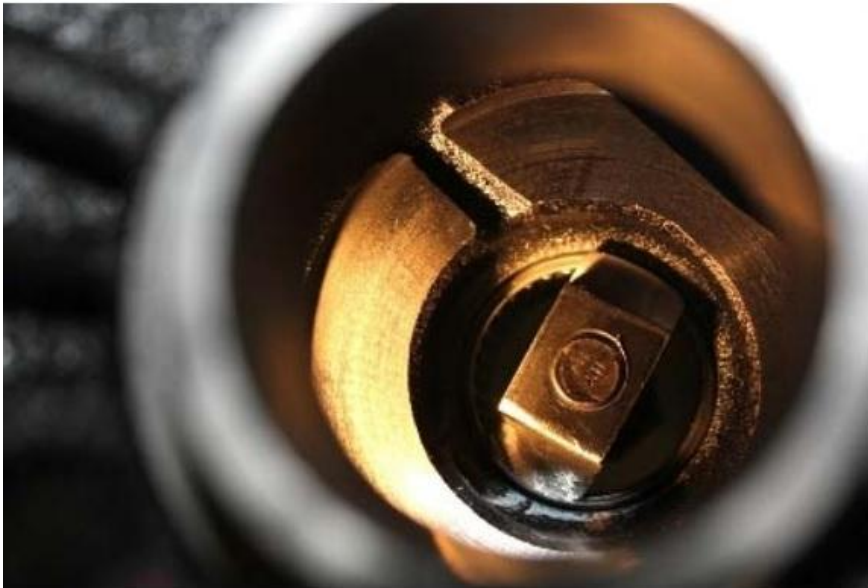
- E. Hand tighten nut to plate, and insure that tool is centered.
- F. Tighten nut against plate and needle bearing will begin to pull out, it should not take a lot of force to remove the bearing. If it feels as though it is not moving, stop and reposition the Insert. It could be hung on the inside of the carrier and if too much force is applied you will bend the insert or damage the tool, once the needle bearing starts to move then you can proceed faster, but be sure initial pull is pulling on bearing. Here is a picture of the insert positioned from the inside to show how critical the position is.

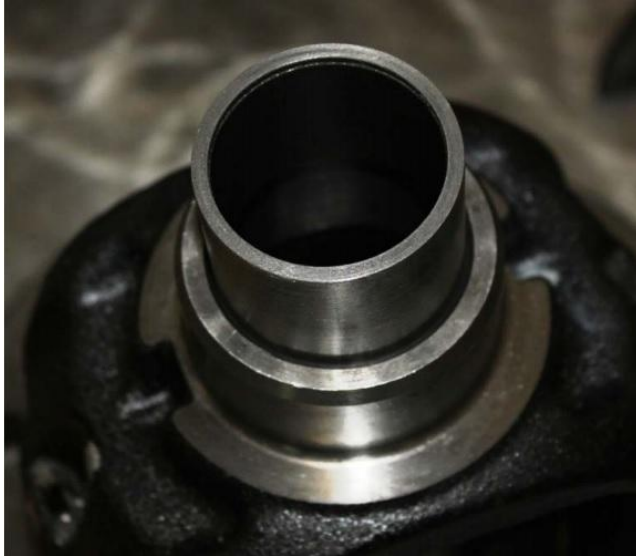
- A. With the bearing now removed. Install replacement bushing with steel face out. The steel face protects the bushing while it is being driven in.

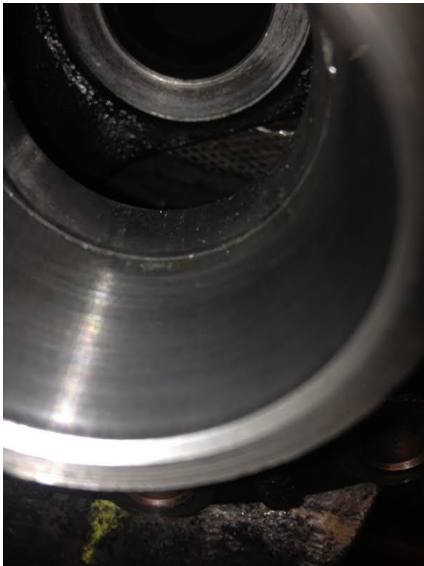
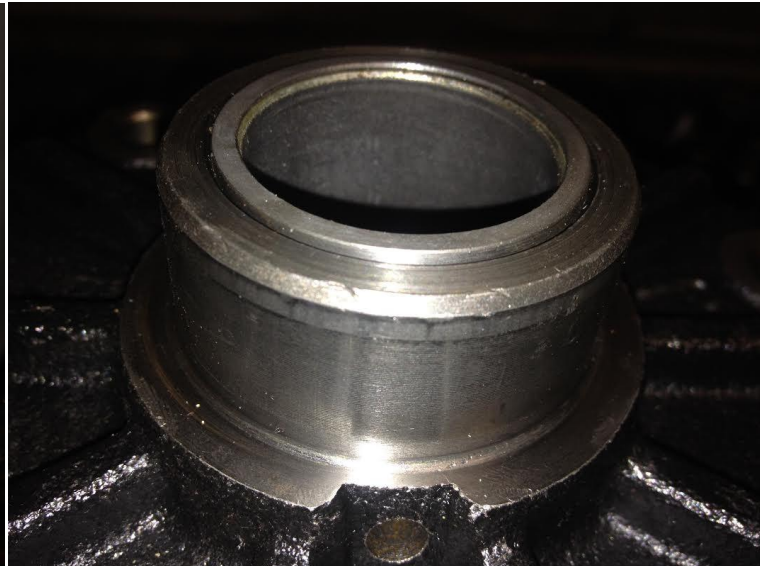
- B. Install bushing flush with carrier (Be careful not to drive the bushing past flush as the design of the bushing is longer than the stock needle bearing to provide more support, however if driven to much past flush it will contact the spider gear)

TECH NOTE: The T7.5 bushing is longer than the stock needle bearing. There is room for the bushing to install flush without hitting the spider gear, however some of the Toyota carriers are not bored straight through and there is a ridge on the inside. The ridge will stop the bushing from seating flush. **Installed height is between .030-.065 off of the carrier bore as acceptable.** The bushing can be driven past the ridge of you hit it hard enough but it will damage the bushing and cause the CV shaft not install properly. Drive bushing in to carrier with even firm blows once you feel it stop verify height is between .030 -.065
